# Comparison of oxide layers formed on the low-cycle fatigue crack surfaces of Alloy 690 and 316 SS tested in a simulated PWR environment

Keywords: Environmentally-assisted fatigue Alloy 690 316 SS Oxide layer Electrochemical analysis

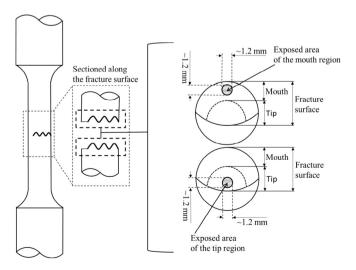
**Fig. 1.** Schematic diagram of specimen preparation for the electrochemical measurements taken from the LCF tested specimens of Alloy 690 and 316 SS. Exposed areas at the crack tip and mouth regions are indicated.

The electrochemical measurements were performed at the crack tip and mouth regions of the LCF tested specimens as shown schematically in Fig. 1. The specimens for electrochemical measurements were taken at the fatigue crack surface of the LCF tested

specimens of Alloy 690 and 316 SS. The specimens were then masked with silicon sealant, leaving only the exposed areas of a few mm<sup>2</sup> at the 'crack tip' and 'mouth' regions of the fatigue crack surface as shown in Fig. 1. The location of the exposed area was maintained as close as possible to the intended locations, such that exposed area of the 'crack tip' and 'mouth' regions was kept within 0.5–1.0 mm from the fatigue crack tip and the outer surface, respectively. The intention was that, by placing the exposed area of the 'crack tip' region as close as possible to the real fatigue crack tip, the characteristics of oxides formed at the real fatigue crack tip 'region.

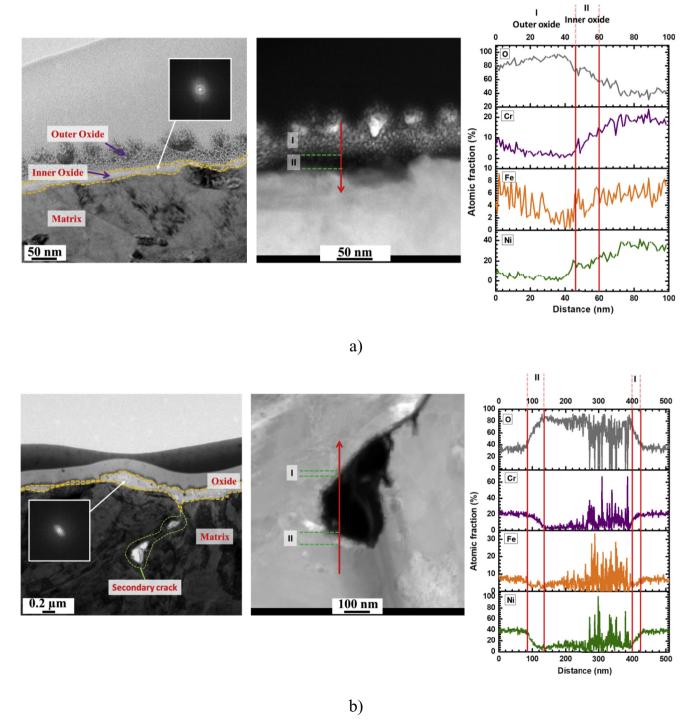
Fig. 4. Cross-section TEM analyses (HRTEM image analysis, diffraction analysis, STEM EDS line scanning analysis) of LCF tested Alloy 690 (a) at the crack tip and (b) the mouth regions of the LCF crack, respectively. The dashed line indicates the oxide films formed on the LCF crack surface.

Fig. 4 shows the cross-section TEM analysis results of the fatigue crack surface of Alloy 690 containing oxide layers at the crack tip

and mouth regions of the LCF crack. EDS line scanning analyses were performed on the LCF crack surface of Alloy 690 and the results are also shown in Fig. 4. As shown in the figure, the oxides formed at the mouth region are much thicker (100–300 nm) than those at the crack tip region (50–70 nm), which is expected considering that the mouth region is exposed to PWR water for much longer than the crack tip region. It seems that, at the mouth region, outer layer with small amount of Fe is present on top of the inner layer rich in Cr and Ni. Meanwhile, at the mouth region, the inner layer is well developed but the presence of outer layer is not

clear. The EDS line scanning results show that Cr and Ni are dominant while Fe is mostly absent in the oxide layer at the mouth region. Therefore, nickel chromite (NiCr<sub>2</sub>O<sub>4</sub>) would be the probable oxide formed on the fatigue crack surface of Alloy 690, which is consistent with the results of previous studies [20,21]. Interestingly, TEM diffraction analysis shows that the oxide layers are mostly an amorphous structure at both regions. This is rather surprising as the presence of crystalline Cr-rich oxides on Alloy 690 exposed to PWR water have been well reported by other researchers [18,19].

exposed metal surface would provide the re-passivation of the metal surface at the crack tip region. If the oxide layers are sufficiently protective, the further dissolution of metal could be prevented, and the thickness of the oxide layer could be minimized. According to STEM/EDS analysis shown in Figs. 4 and 5, the inner oxide layers formed at the crack tip region are rich in Cr and Ni for Alloy 690 and Cr and Fe for 316 SS, respectively, while its thickness is somewhat greater for 316 SS compared to Alloy 690. Meanwhile, Alloy 690 (with thinner inner oxide layer) showed about twice longer LCF life than 316 SS (with thicker oxide layer) as shown in Fig. 2. Therefore, the thickness of inner Cr-rich oxide layer at the crack tip region could not be correlated with the LCF life in a simulated PWR environment.

oxide films is related to the chemical compositions and structure of oxide films, and the Fe-rich oxide films exhibits n-type behaviors while Cr-rich oxide films p-type behaviors. The TEM results reveal that the oxide films formed on Alloy 690 is Cr enriched and the oxide films on 316 SS is consisted of Fe-rich outer oxide particles and Cr-rich inner layers, as shown in Figs. 4 and 5. The M-S plots are well in accordance with the microstructural analysis.

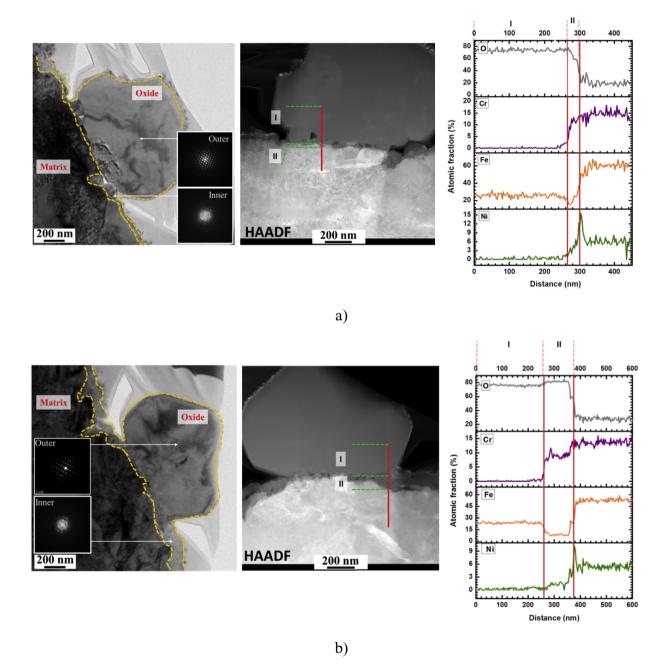
Fig. 5. Cross section TEM analyses (HRTEM image analysis, diffraction analysis, STEM EDS line scanning analysis) of LCF tested 316 SS (a) at the crack tip and (b) mouth regions of the LCF crack, respectively. The dashed line indicates the oxide films formed on the LCF crack surface.

Fig. 5 shows the cross-section TEM analysis results of the fatigue crack surface of 316 SS containing oxide layers at the crack tip and mouth regions of the LCF crack. TEM observations on 316 SS oxide reveal similar oxide layer morphology (thin inner layer and large outer nodules) at both the crack tip and mouth regions. The inner layer is somewhat thinner at the crack tip region (30–100 nm)

compared to that at the mouth region (150–200 nm). Nonetheless, the overall thickness of oxide layer is much greater than that of Alloy 690 (Fig. 4). Unlike Alloy 690, crystalline diffraction patterns are clearly detected for both the inner oxide layer and the large outer oxide nodules. The STEM line scanning analysis results show that the large outer oxide nodules are rich in Fe. Considering the diffraction patterns, the outer oxide nodules would be as  $Fe_3O_4$  crystallites at both the crack tip and mouth regions of the LCF crack. Meanwhile, inner oxide layers are rich in Fe and Cr with small amount of Ni at both the crack tip and mouth regions of the LCF crack. The composition of the inner oxide layer formed on 316 SS have been proposed as  $Cr_2O_3$  and (Fe, Ni)Cr\_2O\_4 by several authors [14,15]. Considering that considerable amount of Fe is present at the inner oxide layer, the inner oxide layer would be (Fe,Ni)Cr\_2O\_4.

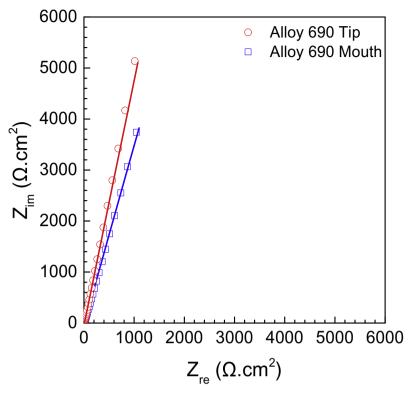
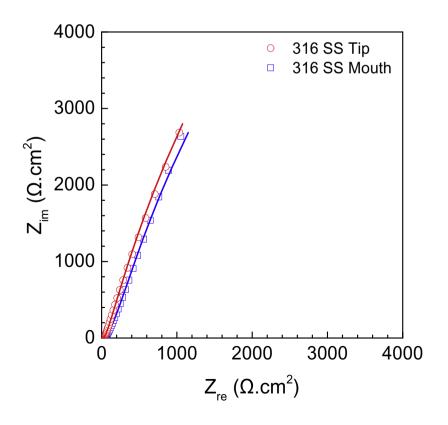
Fig. 6. Impedance spectra (Nyquist plots) of oxide films formed at the crack tip and mouth regions of (a) Alloy 690 and (b) 316 SS LCF crack surface. The lines are fitting results. (in a Borate buffer solution at room temperature).

Fig. 6 and Fig. 7 show the EIS spectra measured for the oxide layers on the fatigue crack surfaces of the LCF tested Alloy 690 and 316 SS. The validity of the results is verified with the Kramers-Kronig transformation (KKT) to check the linearity, causality and stability of system [22]. In this study, the KKT results are in perfect match with the experimental results (not shown here), which confirmed that the requisite conditions are satisfied and the EIS results are considered valid. The Nyquist plots shown in Fig. 6 reveal that the radius of capacitance loops of oxide films formed on the LCF crack surface of Alloy 690 are greater than those of 316 SS. Also, for Alloy 690 and 316 SS, the radius of capacitance loops of oxide films at the mouth regions are lower than in the crack tip regions.

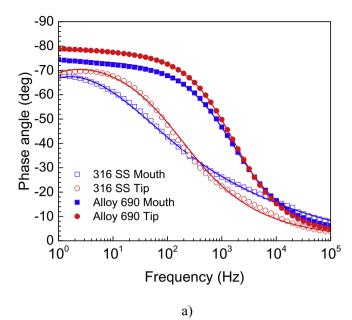
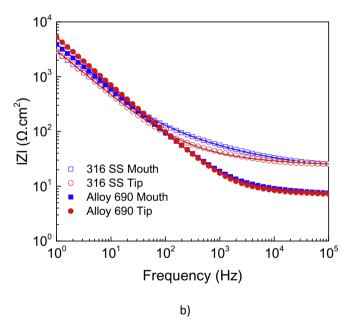
**Fig. 7.** Impedance spectra (Bode plots) of oxide films formed at the crack tip and mouth regions of Alloy 690 and 316 SS LCF crack surface: (a) phase angle vs. log f curves and (b) log |Z| vs. log f curves. The lines are fitting results. (in a Borate buffer solution at room temperature).

formed on the LCF crack surfaces of Alloy 690 and 316 SS, the phase angles of the mouth region are lower than the crack tip region in high frequency range, and this difference is more obvious for 316 SS, as shown in Fig. 7a. The resistance values at the mouth regions are higher than those at the crack tip regions, as shown in Fig. 7b. It reveals that the oxide films form at the mouth regions with lower film capacitance and higher resistance values, indicating the oxide films in the mouth regions being thicker. The resistance values in high frequency range of Alloy 690 being lower than 316 SS indicates that thinner oxide films formed on the LCF crack surface of Alloy 690 than 316 SS. These are in good agreement with the cross section TEM observation of oxide films shown in Figs. 4 and 5. According to Fig. 7, in the medium-low frequency range of Bode plots, the phase angles at the mouth regions are higher than those at the crack tip regions, and the resistance values of the mouth region are lower than the tip region for Alloy 690. The difference of resistance values between the mouth and crack tip regions are not obvious for 316 SS in the medium-low frequency range of Bode curves. These results reflect that the oxide films formed on the crack tip regions have higher reaction resistance than the mouth regions. Lower phase angles and higher resistance of Alloy 690 in medium-low frequency range of Bode curves indicate the oxide films of Alloy 690 have higher reaction resistance than 316 SS.

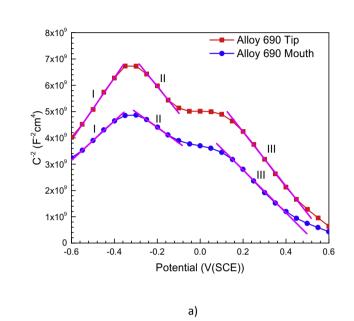
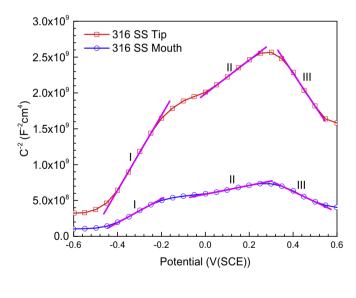
**Fig. 9.** Mott-Schottky plots of oxide films formed at the crack tip and mouth regions of the LCF crack surface of (a) Alloy 690 and (b) 316 SS (obtained in Borate buffer solution at room temperature).

Fig. 9 shows the C-2 SC vs. potential plots measured for the surface oxides formed at the crack tip and mouth regions of the LCF crack surface of 316 SS and Alloys 690. The calculated defect densities on the basis of equations (1) and (2) are presented in Tables 4 and 5. The plots of the M-S relationship for Alloy 690 exhibit positive slope at the potential of -0.6 V(SCE) up to around -0.3 V(SCE)(region I), indicating the characteristic of n-type semiconductor. Negative slopes are shown at the potential from around -0.3 V(SCE) to -0.1 V(SCE) (region II) and from around 0.1 V(SCE) to 0.5 V(SCE) (region III), indicating the feature of p-type semiconductor. These results suggest that the oxide layers behave similar to p-n heterojunction semiconductors. The measured C-2 SC of oxide film formed at the mouth region of Alloy 690 is lower than that at the crack tip region in the whole potential scale. According to the calculated point defect densities shown in Table 4, the N<sub>D</sub> and total  $N_A$  ( $N_A$  in region II and region III) at the mouth region are higher than those at the crack tip region, indicating the point defect densities at the mouth region are higher than those at the crack tip region.

Although the M-S curves of Alloy 690 and 316 SS show p-n heterojunction semiconductors features, the p-type character is dominant for Alloy 690 and n-type character is dominant for 316 SS. It has been reported [30-32] that the semiconductor properties of

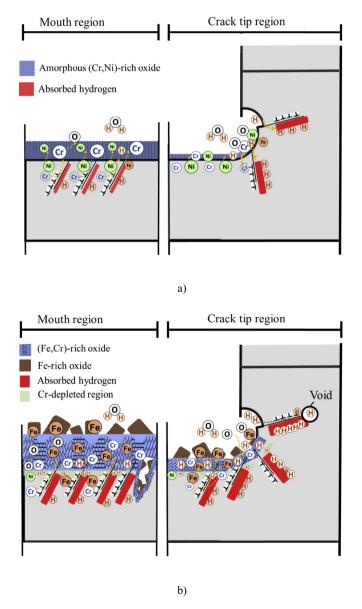
**Fig. 10.** Schematic illustration of (a) Alloy 690 and (b) 316 SS describing the corrosion mechanisms and fatigue behavior during LCF test in a PWR environment.

The corrosion process on the LCF crack surface and the environmentally-assisted fatigue behavior of Alloy 690 and 316 SS are described schematically in Fig. 10. For Alloy 690, a thin (Cr,Ni)-rich amorphous oxide is formed on the LCF crack surface. For 316 SS, the oxide film is consisted with (Cr,Fe)-rich spinel-type inner oxide film and Fe-rich magnetite outer oxide nodules. Overall, the oxide film is much thicker for 316 SS than for Alloy 690, as shown in Figs. 4 and 5. The ex-situ electrochemical tests demonstrated that the oxide films of Alloy 690 are with lower point defect densities and higher reaction resistance, suggesting that the corrosion rate of Alloy 690 is lower than 316 SS in the case of current study.
